SYNOPSIS

'UNCLEANABLE' HEAT EXCHANGER BUNDLE SAVED WITH EMBC TECHNOLOGY

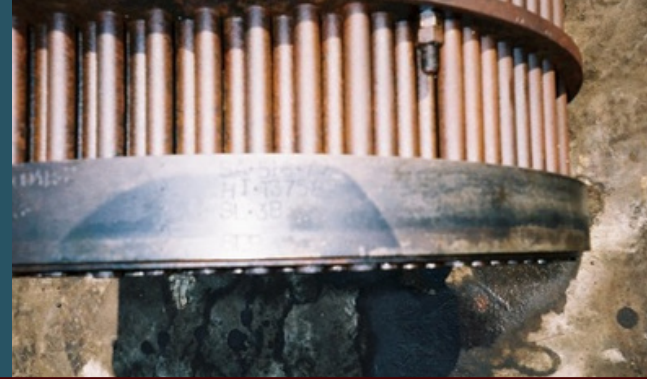
A large heat exchanger bundle at an asphalt plant had been idle for four months with hardened residue that other contractors could not remove with hydroblasting. In six hours, Blue Wolf's EMBC bundle cleaning technology fully cleaned and tested the unit, returning the heat exchanger to maximum efficiency.

The Blue Wolf team brought our Enclosed Mobile Bundle Cleaner (EMBC) unit to the plant. This unit uses high volume flow (up to 1,500 gpm) of cleaning agent in an enclosed machine. The solution is heated and moderately pressurized and pumped through more than 400 spray jets while the bundle is constantly rotated.

The jets, coupled with the constant rotation of the bundle, provide constant contact with the cleaning agent down both sides.

Within 6 hours Blue Wolf loaded the bundle into our EMBC, enclosed, cleaned and then tested the unit. Blue Wolf then cleaned and vac-truck emptied the area. The cleaned unit was returned to 100% efficiency and the customer estimated a payback period of less than a year plus on-going energy savings.

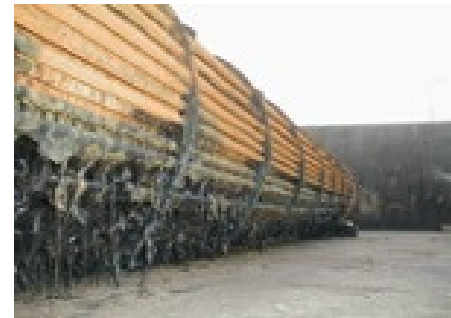
Before

The asphalt plant had historically cleaned the bundle using contract hydroblasting. The contractors hydro blasted the test bundle for six days but were unable to remove the fouling. This resulted in an incomplete shell-side cleaning, and extensive fouling of the cement pad the bundle was sitting on.

The bundle then sat idle for four months while asphalt residue hardened and the pad further deteriorated.
